X International Conference on Structural Dynamics, EURODYN 2017

Dynamic evaluation of a historic fountain under blast loading

F. Javier Baeza^a, Salvador Ivorra^{a*}, David Bru^a, F. Borja Varona^a^a*Civil Engineering Department, University of Alicante. Aptd. 99, Alicante 03080, Spain*

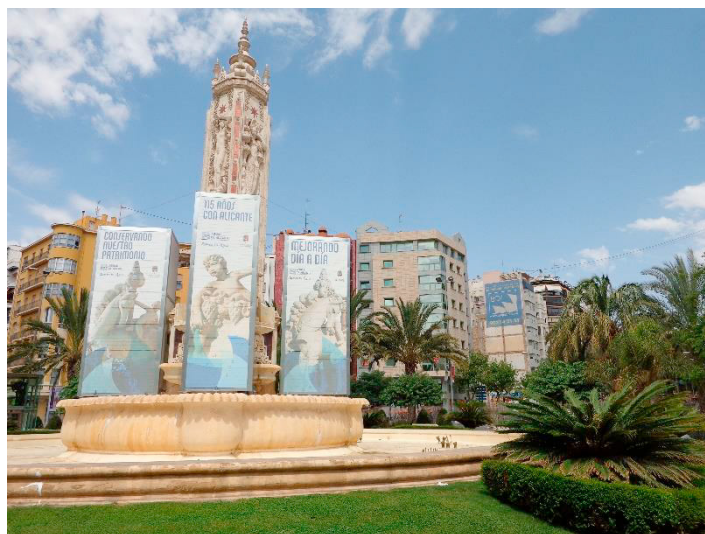
The fountain in the center of the Plaza de los Luceros is one of the most important monuments of the city of Alicante (Spain). Designed in a modernist style, this structure was built by the local artist Daniel Bañuls in 1930. It is composed of three different parts (Figure 1): a vase filled with water (with diameter equal to 20.6 m), a central body 16 m high, and four horse sculptures (hidden inside the protective screens seen in Figure 1).

Fig. 1. General view of the fountain of Plaza Luceros in Alicante (Spain).

masclatàs. Around each sculpture a protective screen made in composite materials has been installed each year to protect them from blast induced vibrations (Figure 1).

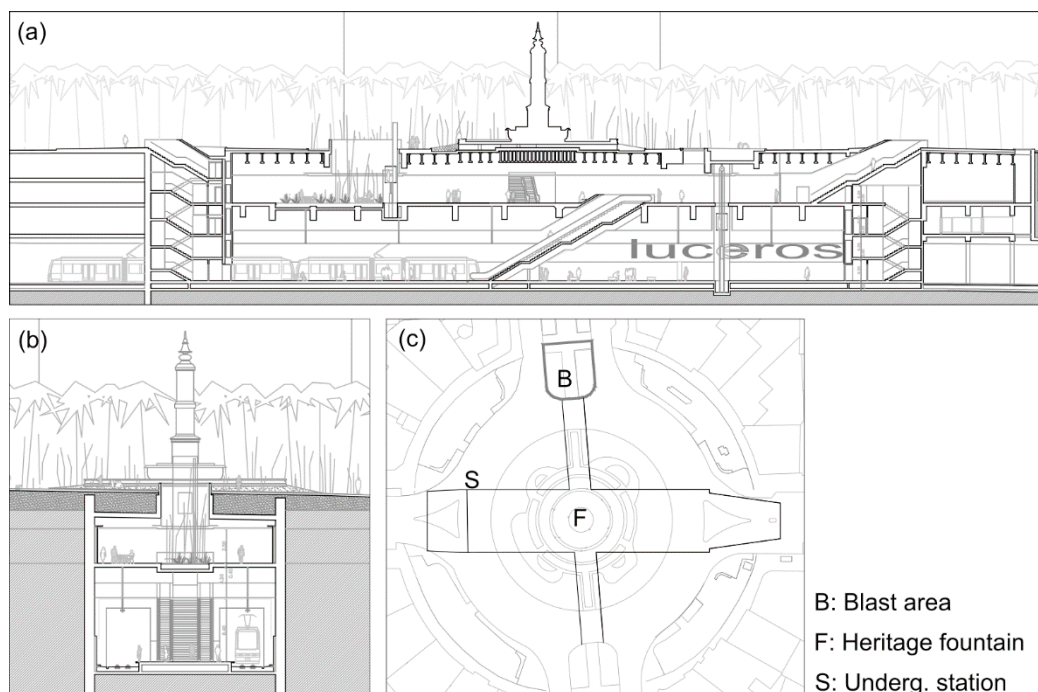
The monument was once totally dismantled, and reconstructed later, due to the works carried out during the construction of an underground railway station under the Plaza (Figure 2). Therefore, the monument is currently supported by a RC slab made in prestressed concrete beams, as can be observed in the section included in Figure 2. Besides, before and after this reconstruction, the monument has been repaired several times in the early years of XXI century (2003, 2011 and 2015) due to different pathologies. The most frequent were superficial discoloration, cracking and spalling because of the nearby road traffic (this Plaza is one of the main traffic nodes of the city center), water from the fountain, and corrosion of the embedded steel elements of the fountain facilities. In the last intervention, some parts were retrofitted with glass fiber reinforced composites to enhance their durability.

Fig. 2. Views of the underground station and fountain location: (a) W-E longitudinal section; (b) N-S section; (c) Plan view.

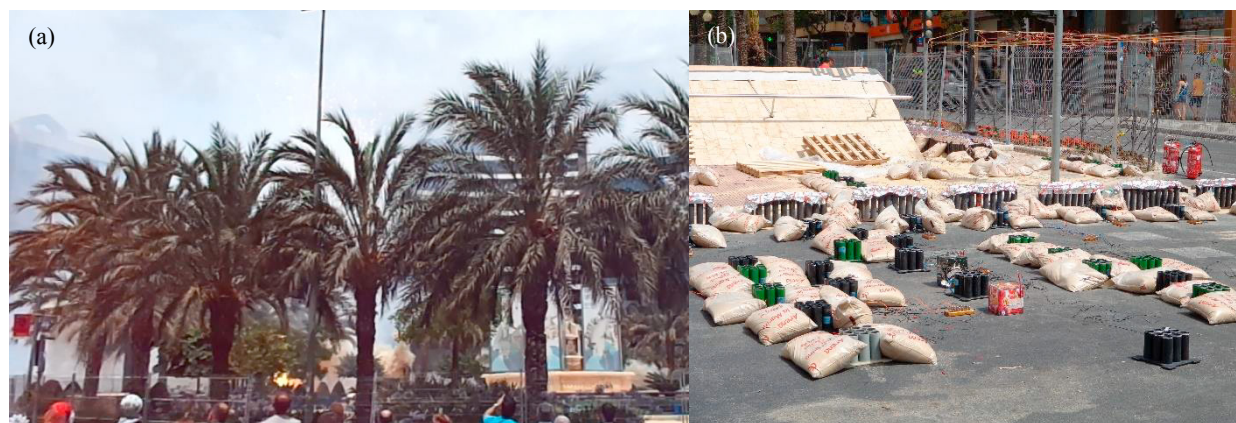
Fig. 3. (a) General view during fireworks blasting. (b) Explosive material distribution.

Furthermore, blast-induced vibrations should be considered as another damage source, because every year for the city festivities several fireworks (called *mascletàs*) are held in the Plaza, near the fountain. Figure 3(a) shows an example of these shows, while Figure 3(b) includes the preparation and placement of the explosive charges. The location of these *mascletàs*, typical in the east-coast of Spain, led to a public debate about the possible effects on the fountain's health. Recently, temporary measures were taken to protect the four horse sculptures during the
